SERT News

Volume 1 Issue 2

2nd Quarter 2001

A publication of the U.S. Coast Guard's Salvage Engineering Response Team (SERT)

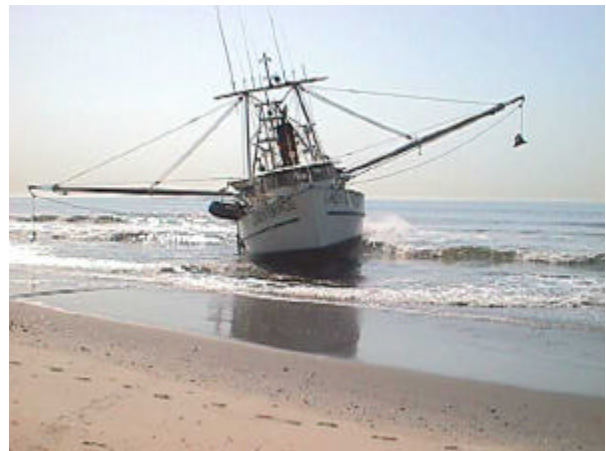
Due to the grounding, the vessel had sustained substantial damage, resulting in the flooding of the vessel's lazarette, fish hold and the main engine room. In addition, the vessel incurred damage to the interior bulkheads, rudder, propeller, and shaft.

Despite the successful freeing of the vessel, she sank approximately one hour after being freed. It is our opinion that the vessel sank due to progressive flooding into the main engine room through the shaft seal.

LADY GRACE aground at Rockaway Point, Long Island on May 10, 2001. SERT estimated a minimum of 7000-HP to free the vessel at low tide and 3500-HP at high tide.

According to our calculations, the minimum force required to free the vessel at high tide could be generated by a tug with a shaft horsepower of approximately 3500-HP. In addition, we concluded that the vessel would not maintain adequate stability upon refloating if the progressive flooding within the engine room could not be controlled. We also recommended that the vessel's propeller be removed and shaft sealing reinforced to prevent flooding during the refloating operation.
